# Manhole Inspection Summary

Manhole # S17K\_\_046MH

Insp Date: **4/16/08 12:34 PM**

**Location** Address: **2352 willard st**

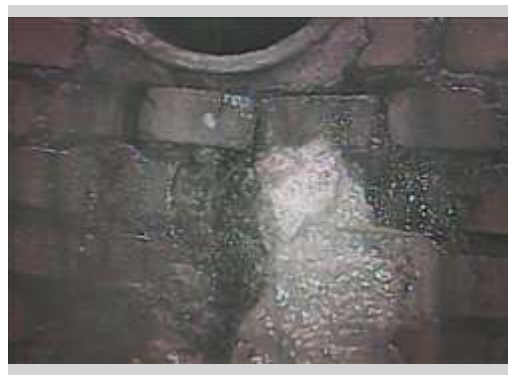
Defect 3

deposits attached encrustation

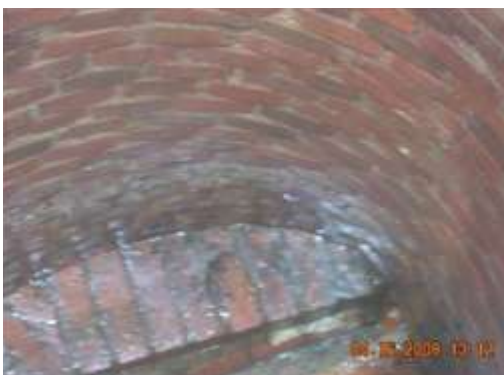
Defect 1

Infiltration: ☐ None ☐ Joint ☐ Cracks ☐ Mortar ☐ Roots ☒ **Wall**

infiltration @ barrel wall

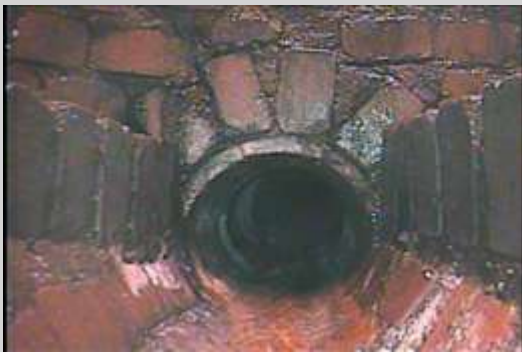
12 O'Clock Outflow

Pipe Height: **8.4** (in.) Rod and Bar (Angled)  
Pipe Material: **Clay** ☐ Pipe Lined  
Invert Depth: **9.46** (ft.) Flow Characteristics: **Slow**  
Deposits: ☒ None ☐ **Mud** ☐ Sludge ☐ Debris ☐ **Grease**  
Silt Depth: **0** (in.) Deposits Extent:  
Infiltration: **Evidence** Pipe Seal Cond: **Cracked**

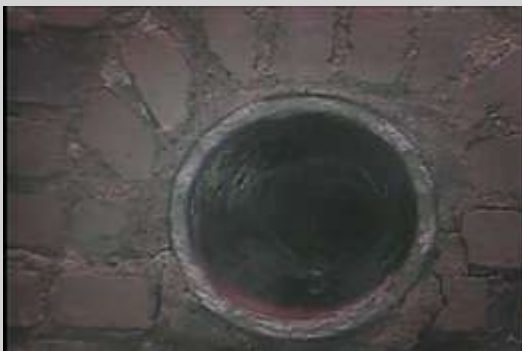
6 O'Clock Inflow

Pipe Height: **8.4** (in.) Rod and Bar (Angled)  
Pipe Material: **Clay** ☐ Pipe Lined  
Invert Depth: **7.29** (ft.) Flow Characteristics: **Fast**  
Deposits: ☐ None ☒ **Mud** ☐ Sludge ☐ Debris ☒ **Grease**  
Silt Depth: **3** (in.) Deposits Extent: **Medium**  
Infiltration: **Evidence** Pipe Seal Cond: **Unknown**

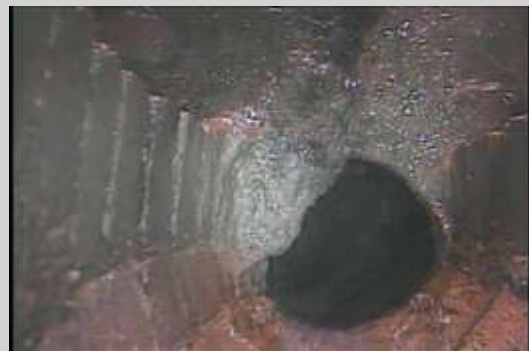
Drop In @ 6 O'Clock

Drop: **Outside** Rod and Bar  
Angled: **Yes** Reading: **8.25** (ft.)  
Inv Depth: **9.25** (ft.)  
Drop Condition: **Open**
